Capsule Summary
SM-665
Fox Tenant House
Leonardtwn vicinity
Private

**Maryland Historical Trust
State Historic Sites Inventory Form**

Survey No. SM-665

SM-665, Fox Tenant House
St. Mary's County
7.1 Description

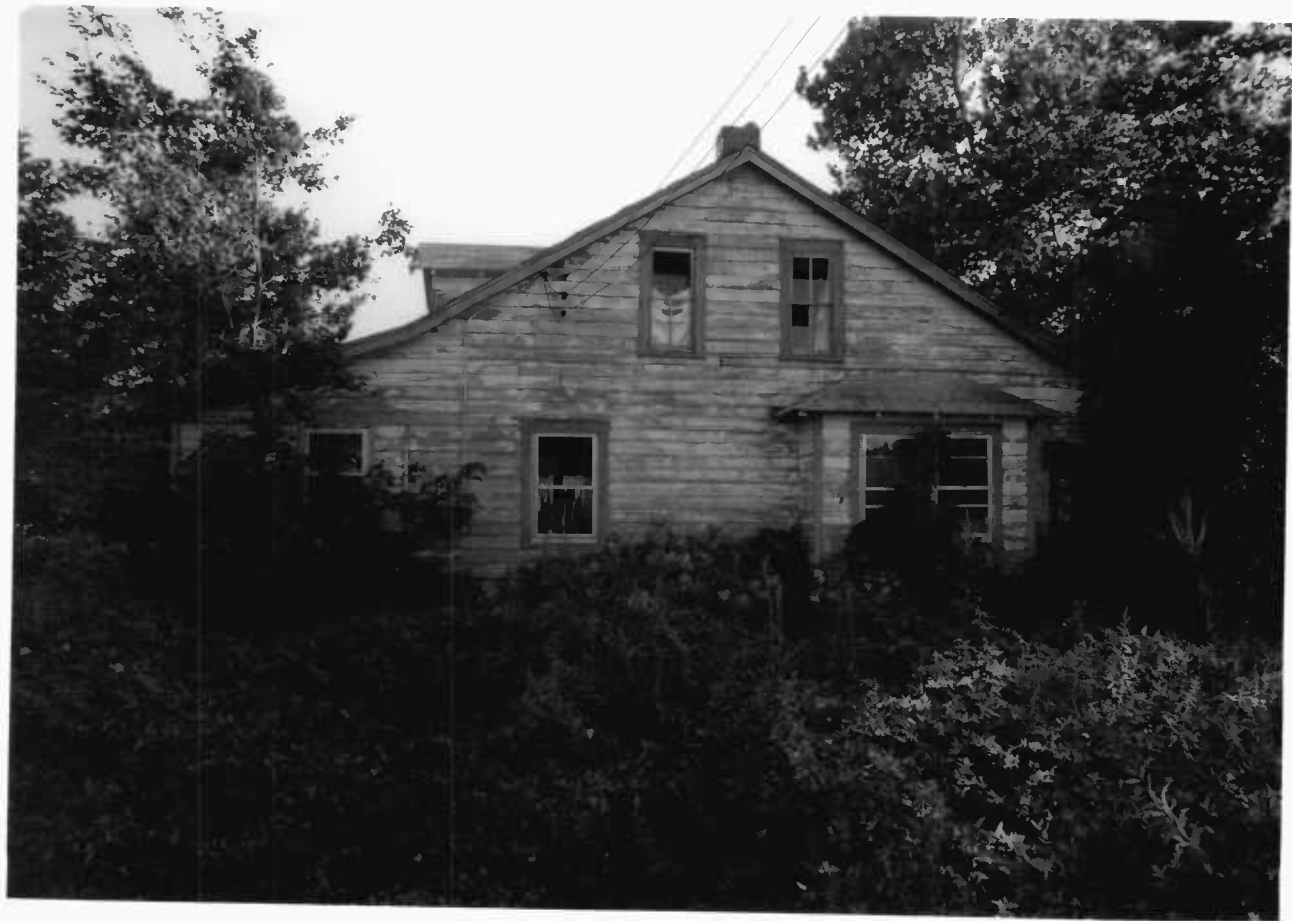
1 of 6

The north elevation's first floor is lit by two six-over-six windows and a shed roof projection with the aforementioned roof of decorative, pressed metal shingles. This projection is pierced by a paired set of six-over-six windows. Like the south elevation, the half story is lit by two, four-over-four windows that lie on either side of a centrally located interior end chimney flue.

N elevation

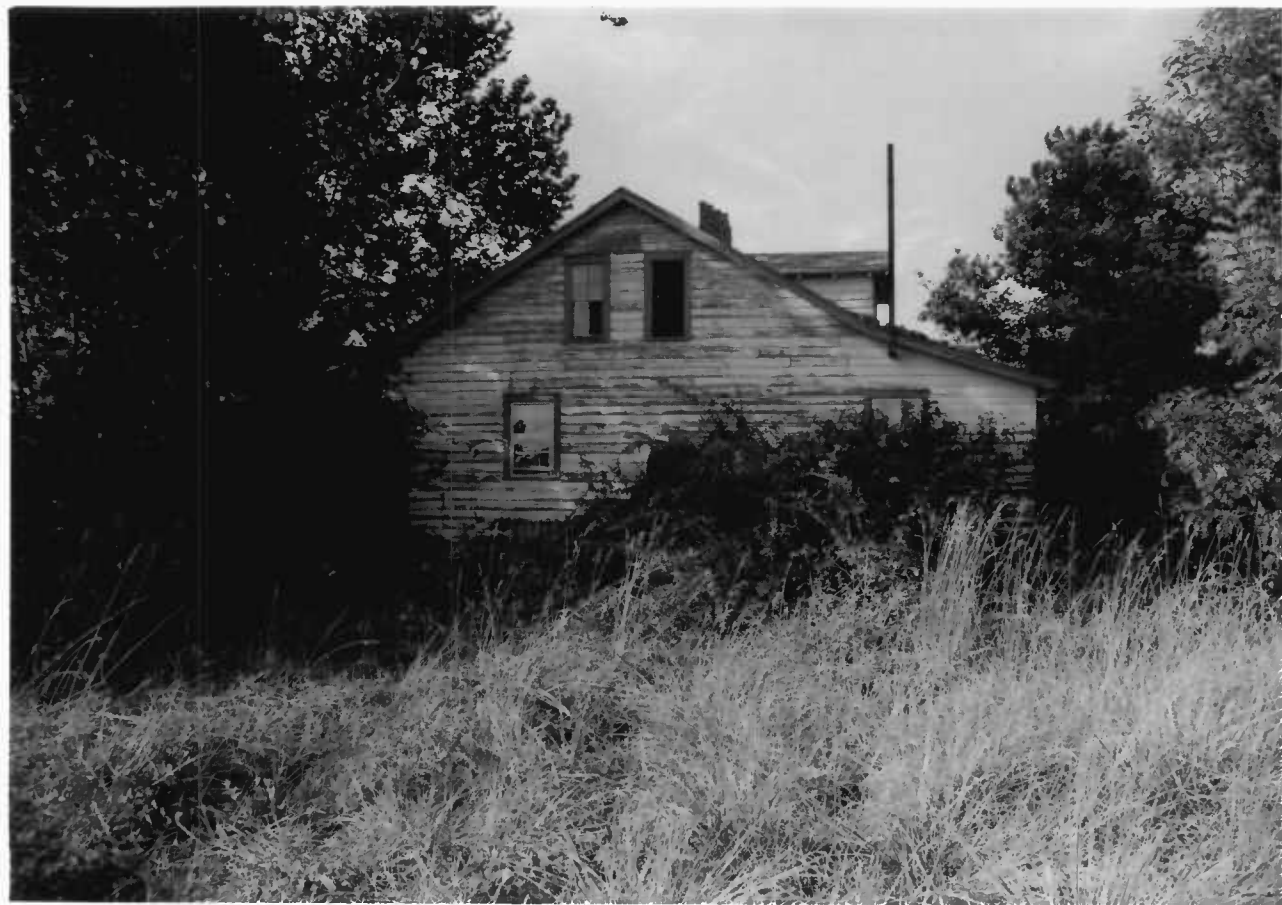
2 of 6

Elevation

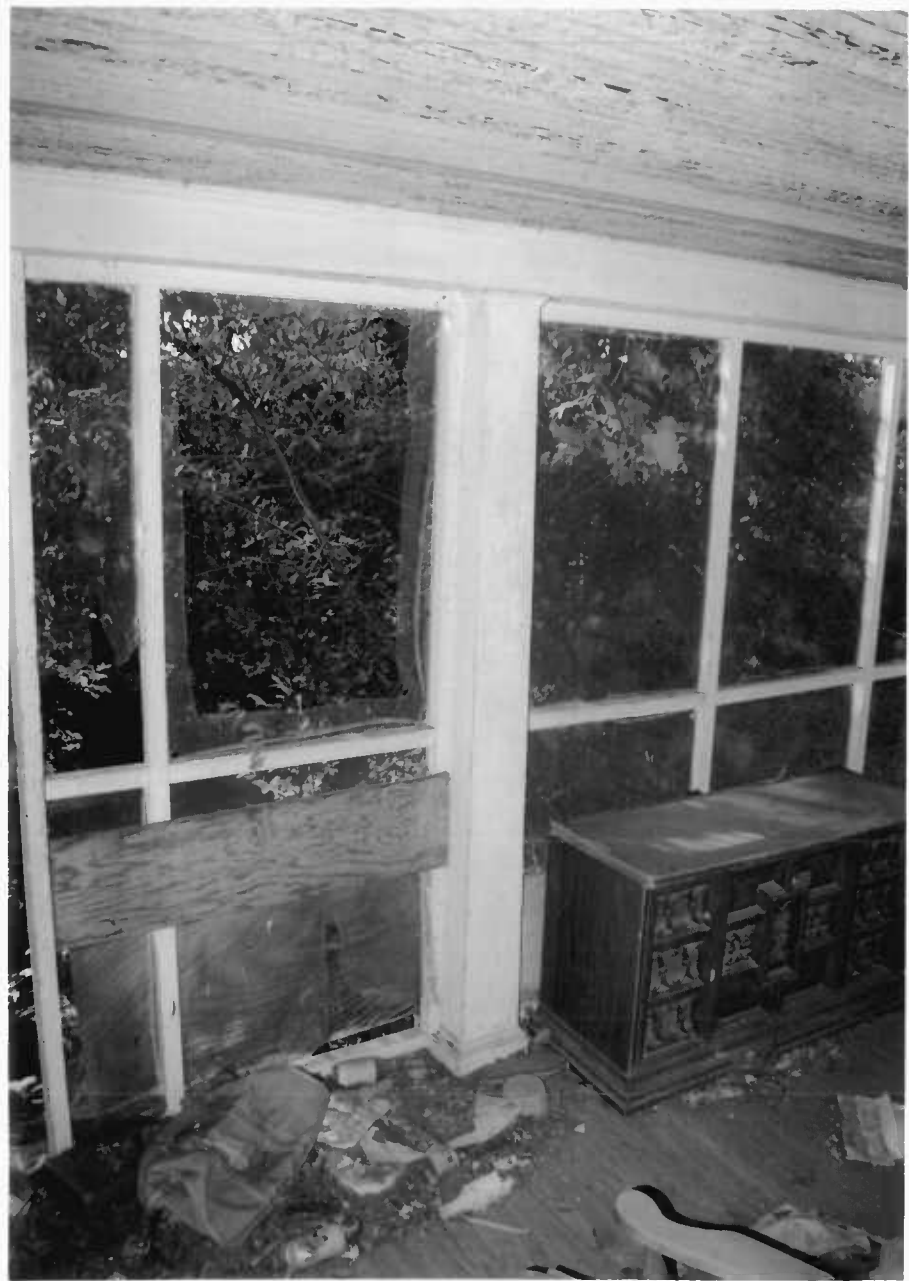
2 of 6

The primary or west elevation is pierced by a centrally located panelled door flanked on either side by a set of paired, six-over-six, double-hung sash windows. All of these bays are shaded by a screened-in porch supported by four, square, classically-inspired columns that descend in size from top to bottom thus suggesting entasis.

Porch Column - looking NW

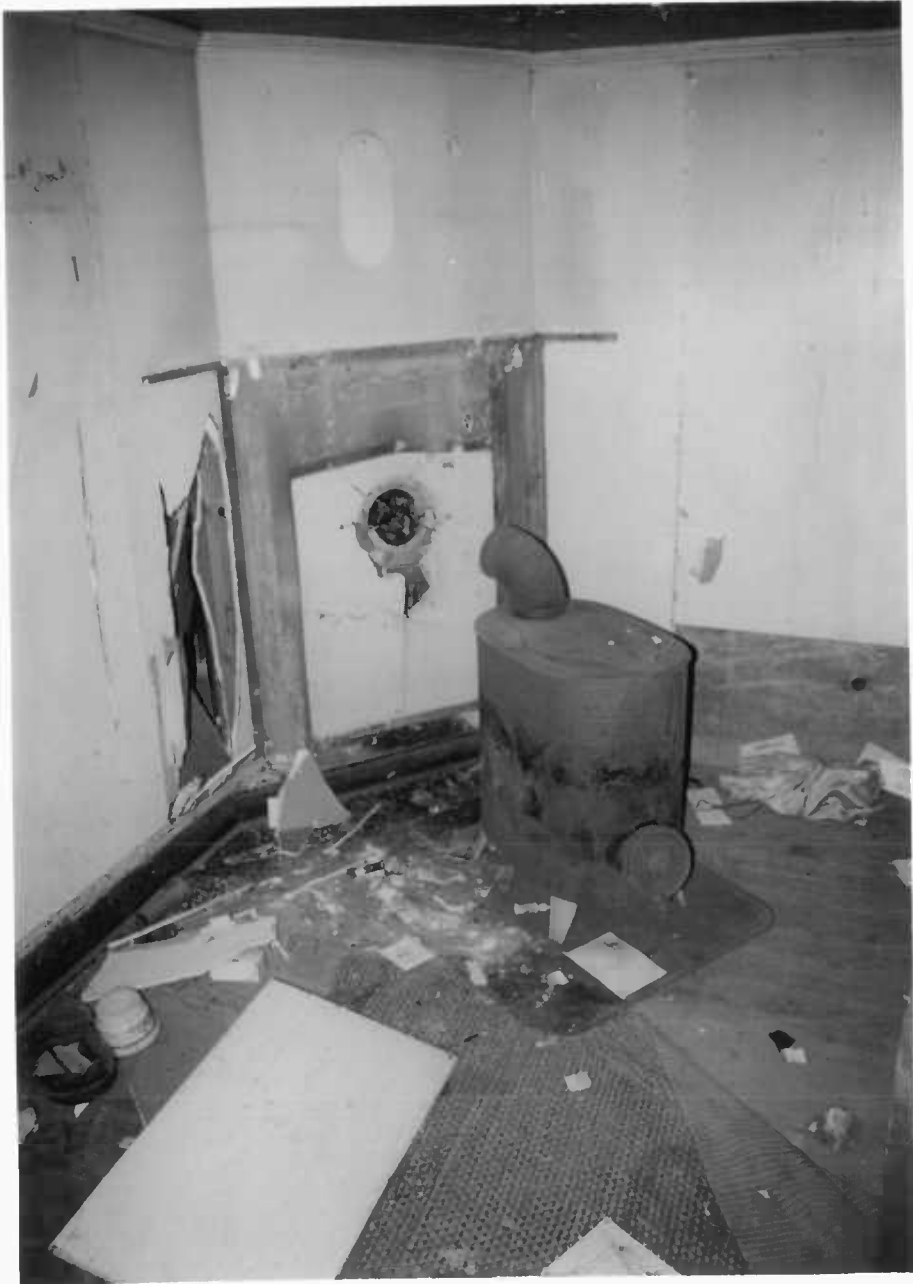
1 of 6

The dwelling has already had most of its original trim, doors, mantels, and architectural details removed. Windows have been broken and much of the interior retains possessions of the house's prior occupants who may have been squatters. The house is in a dilapidated state and will be demolished to make way for a series of Rapid Infiltration Basins designed to supplement the overburdened St. Clements Shores Waste Water Treatment Plant.

Mantel (see Challenge from last page)

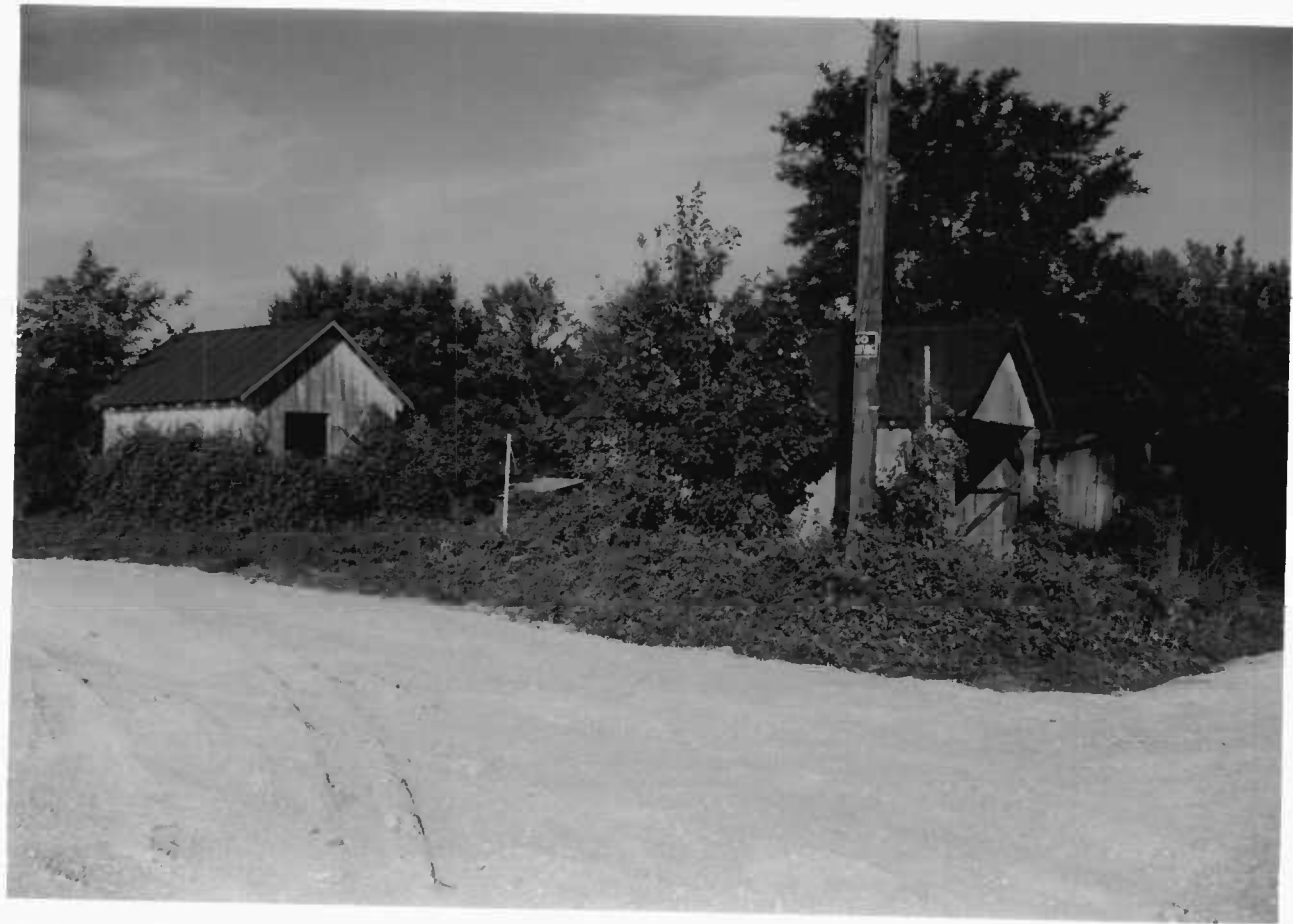
5 of 6

The group of outbuildings situated to the north of the house include the garage, chicken coop, granary, and storage shed. All of these buildings are sheathed with clapboard fastened to the circular sawn frame with wire nails and have roofs covered with raised-seam metal.

Out buildings looking E

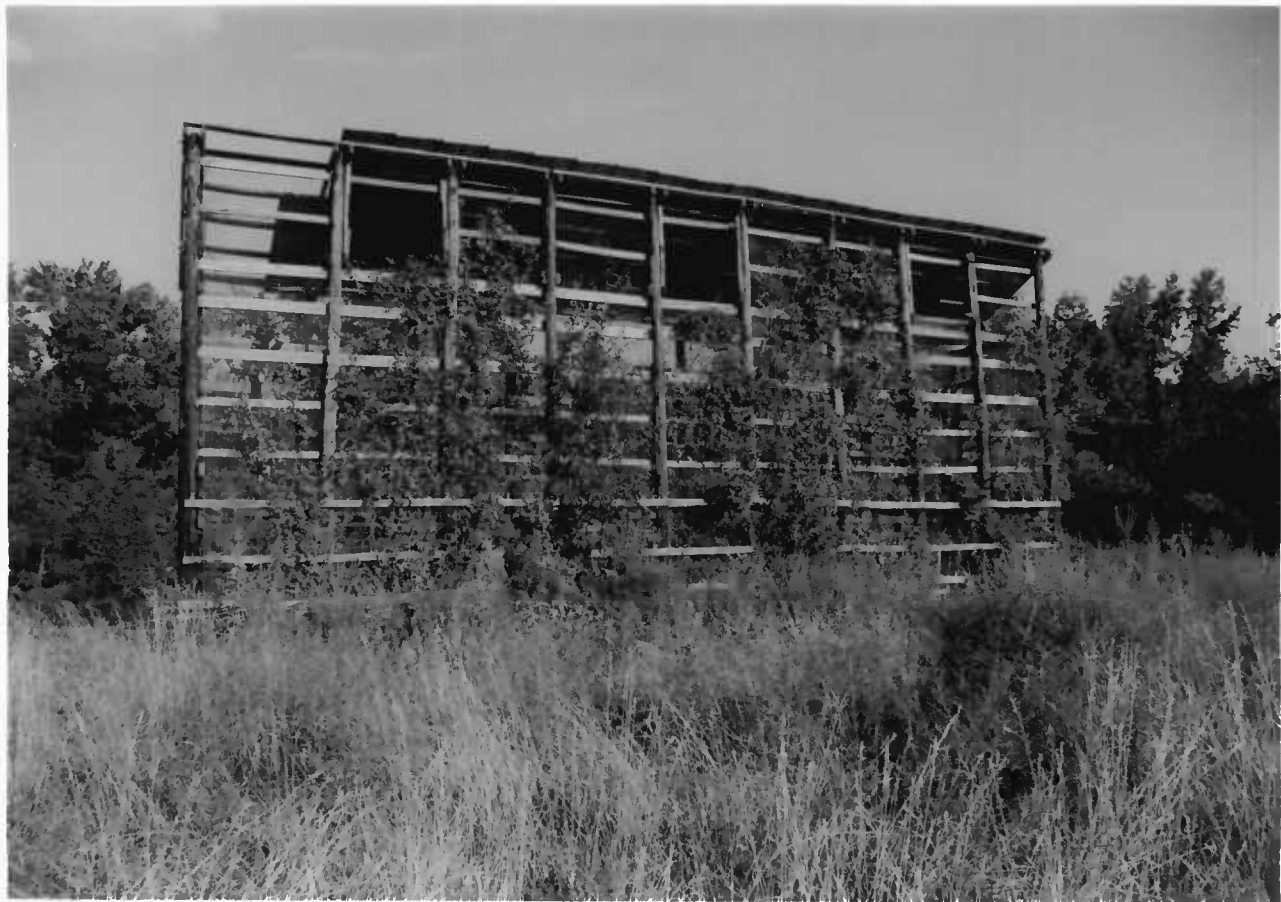
6 of 6

The corn crib and storage shed are located to the east and south of the house. While the storage shed is similar in construction to the aforementioned outbuildings, the corn crib exhibits a mid-twentieth century carry-over of earthfast construction. The crib consists of a series of earthfast, creosote-covered pilings set at regular intervals. Rising up to 25 feet, these pilings support a shed roof covered with raised-seam metal. A tongue-and-groove floor and wire mesh between the pilings represent the primary means of keeping the corn ears from spilling out. A single door is located on this outbuilding's north side.

Main Crib - looking SE
